Institute of Physics and Engineering in Medicine

IPEM MR-SIG Working Party Report: Recommendations for MRI Safety Notices

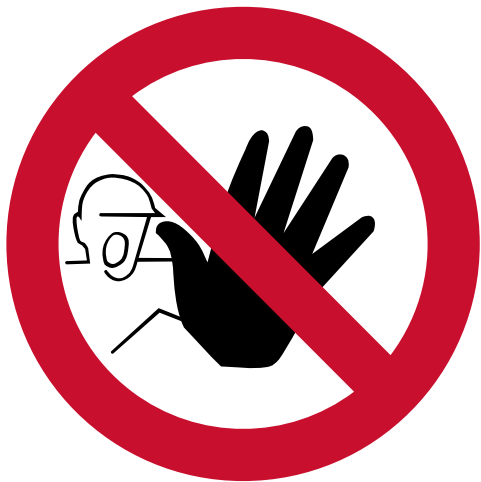
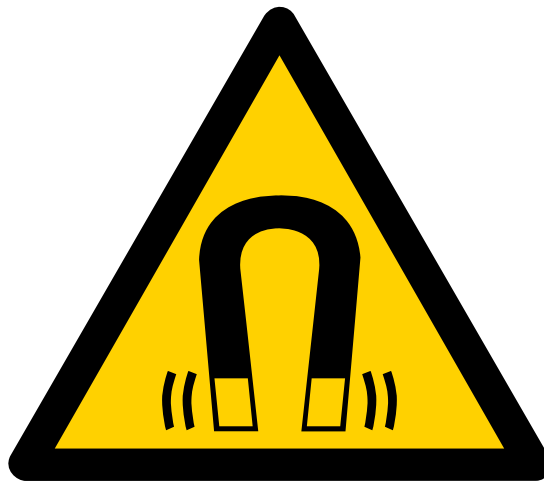
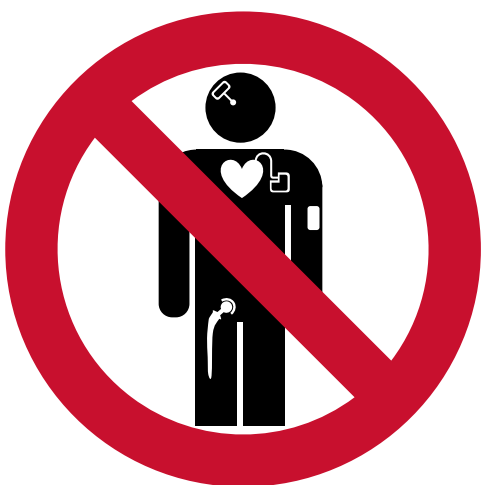
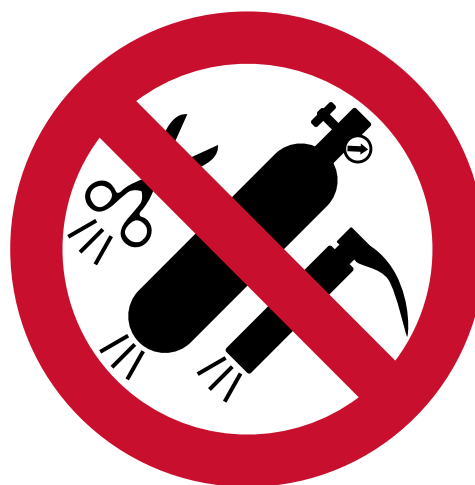
Figure 1: Recommended MRI safety notice for MRI scanner room doors.

- Figure 1 - IPEM recommended MRI safety notice for MRI scanner room doors. For an outwardly opening door, it may be beneficial to also have this safety notice on the inner side.
(suggested size: A1 / 594mm × 841mm / 23.4in × 33.1in)

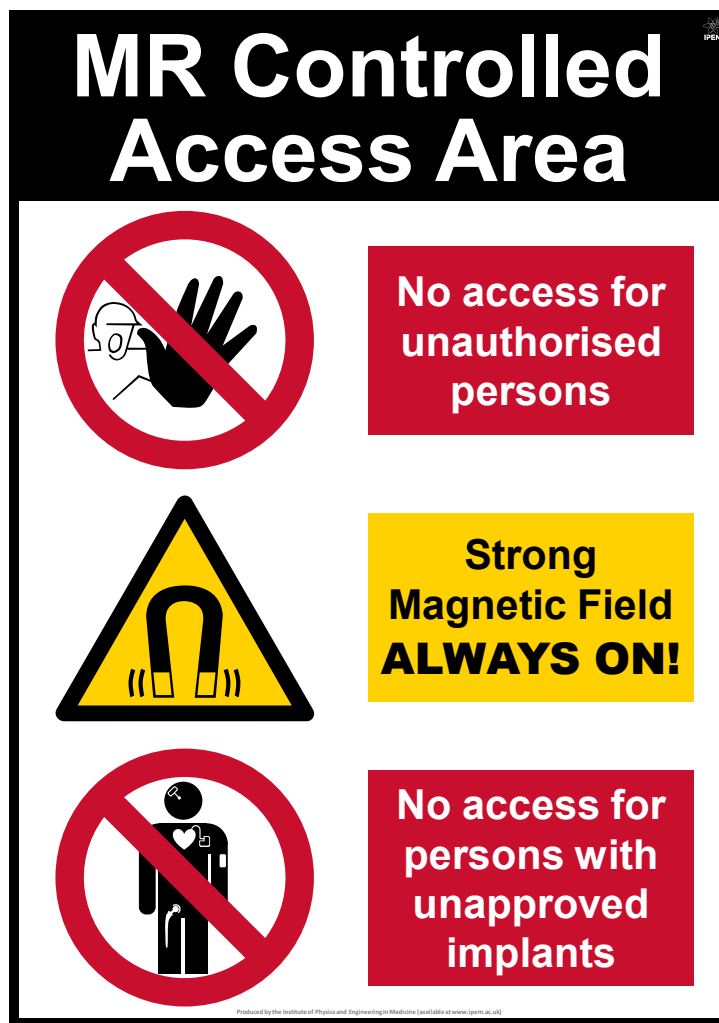
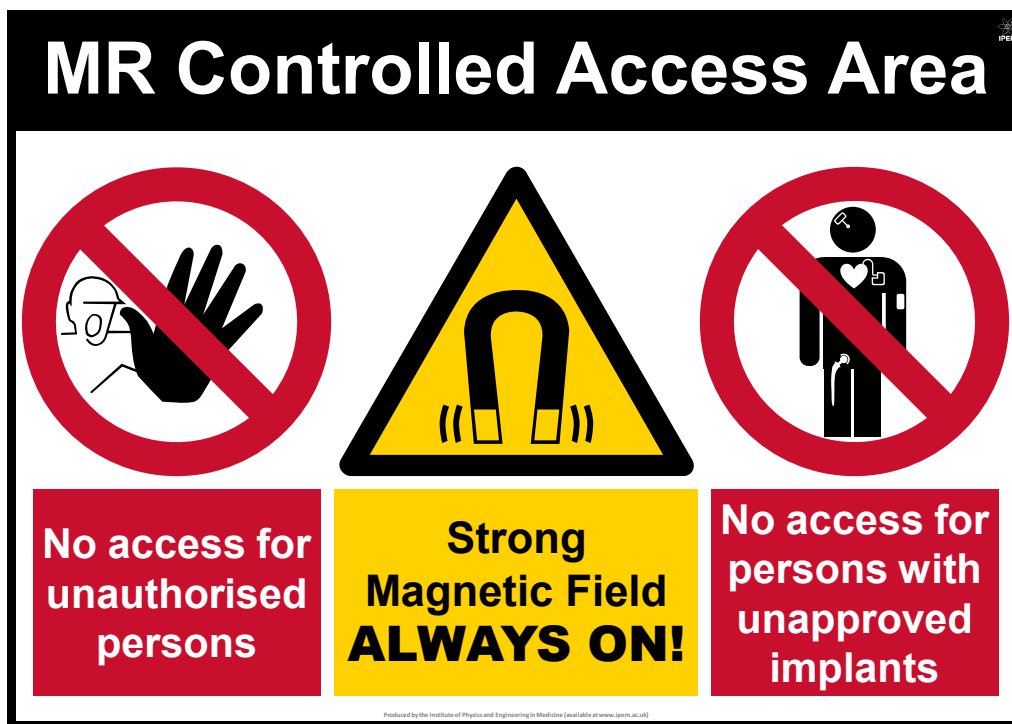
Figure 2: Recommended MRI safety notices for entrance points to the MR Controlled Access Area.

- Figure 2 - IPEM recommended MRI safety notices for entrance points to the *MR Controlled Access Area*, as defined by the MHRA guidelines [19], in portrait and landscape orientations.
(suggested size: A2 / 420mm × 594mm / 16.5in × 23.4in)

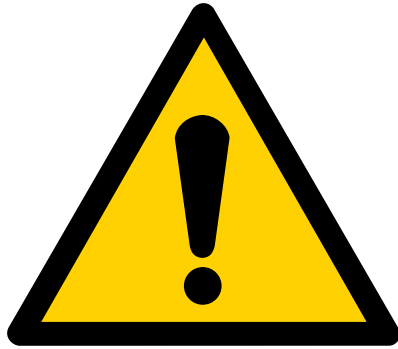
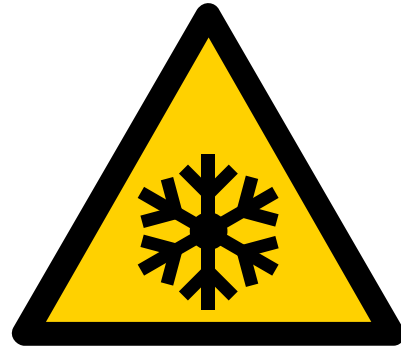
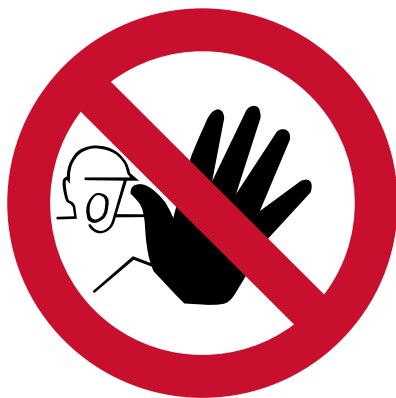
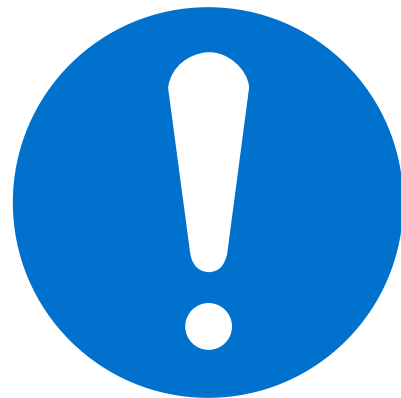
Cryogenic Helium Gas Exhaust
Sudden large volume emission possible
Low temperature and asphyxiation hazard

Figure 3: Recommended MRI safety notice to be placed at approaches to the cryogen quench pipe exhaust.

- Figure 3 - IPEM recommended MRI safety notice to be placed at approaches to the cryogen quench pipe exhaust. The MHRA guidelines recommend a minimum 3m exclusion zone around the quench pipe exhaust [19].
(suggested size: A3 / 297mm × 420mm / 11.7in × 16.5in).

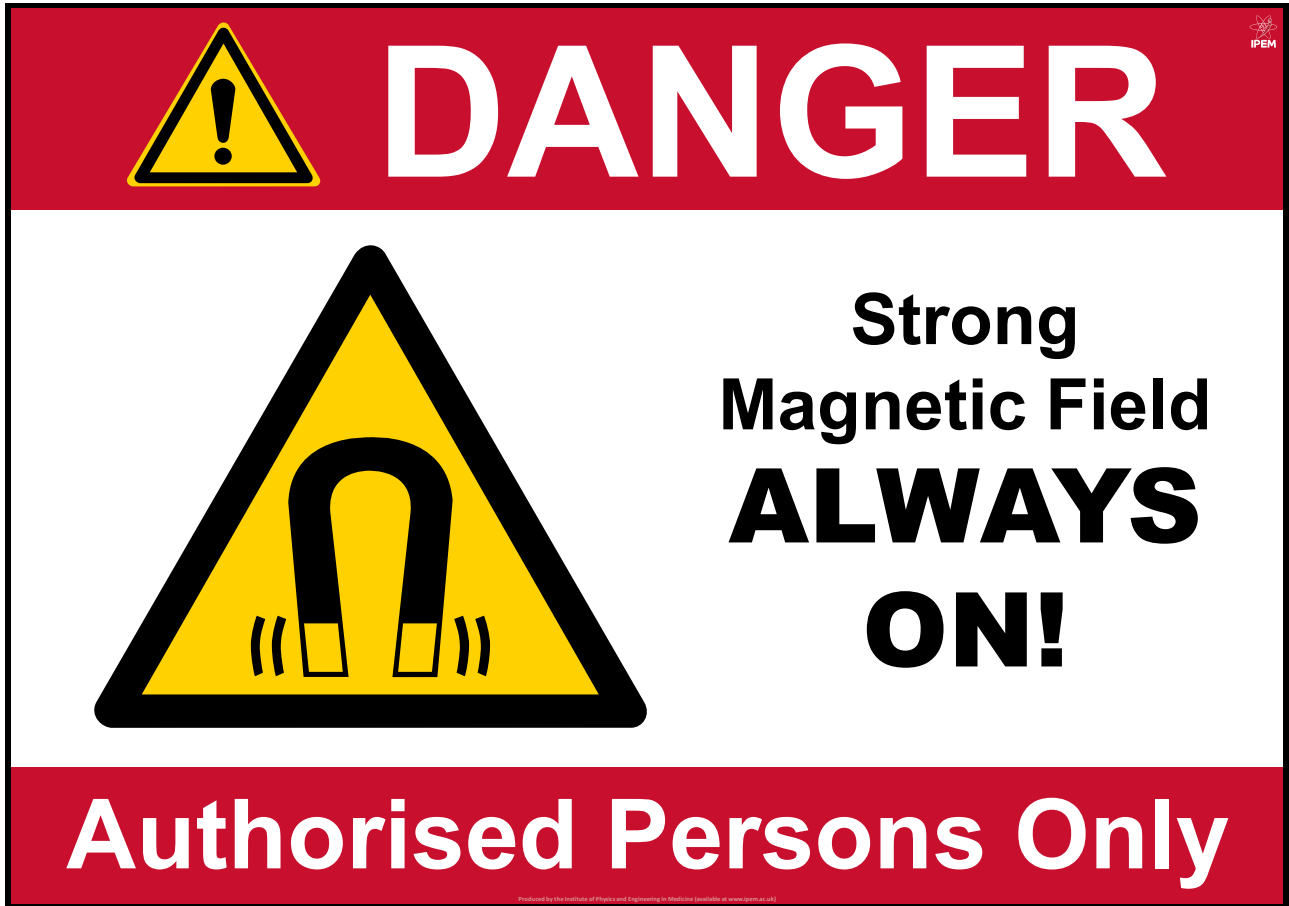
Figure 4: Recommended IPEM MRI safety notice to be placed on the floor or embedded into the floor at entrances to the MRI scanner room.

- Figure 4 - IPEM recommended MRI safety notice to be placed on the floor or embedded into the floor at entrances to the MRI scanner room. It is suggested that this notice fills the full width of the entrance with the aspect ratio retained.

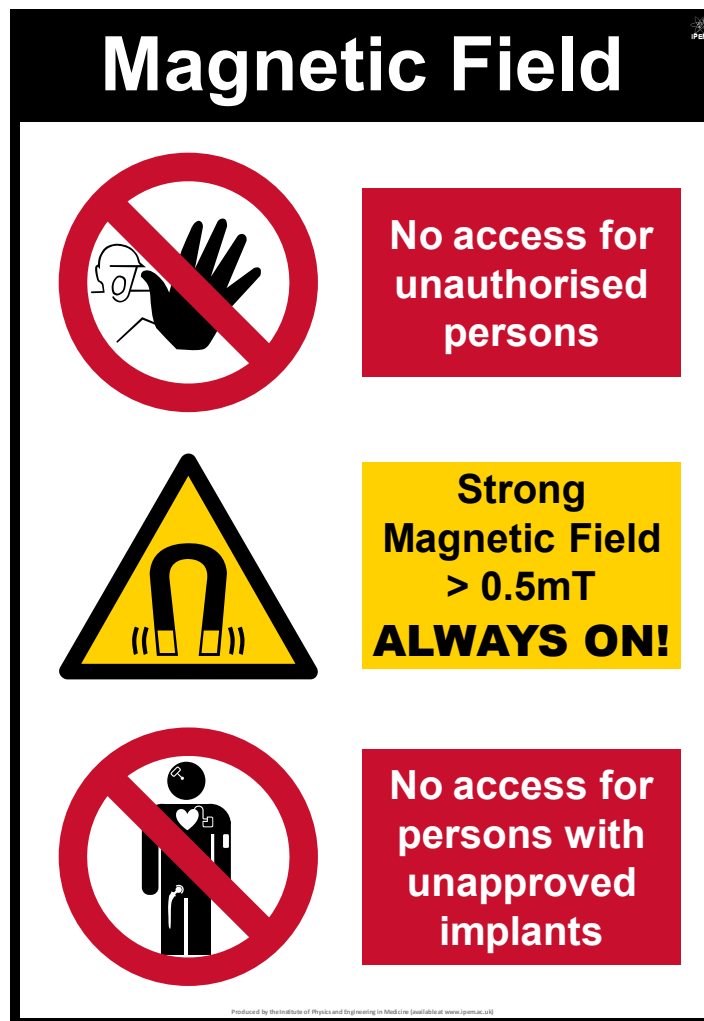
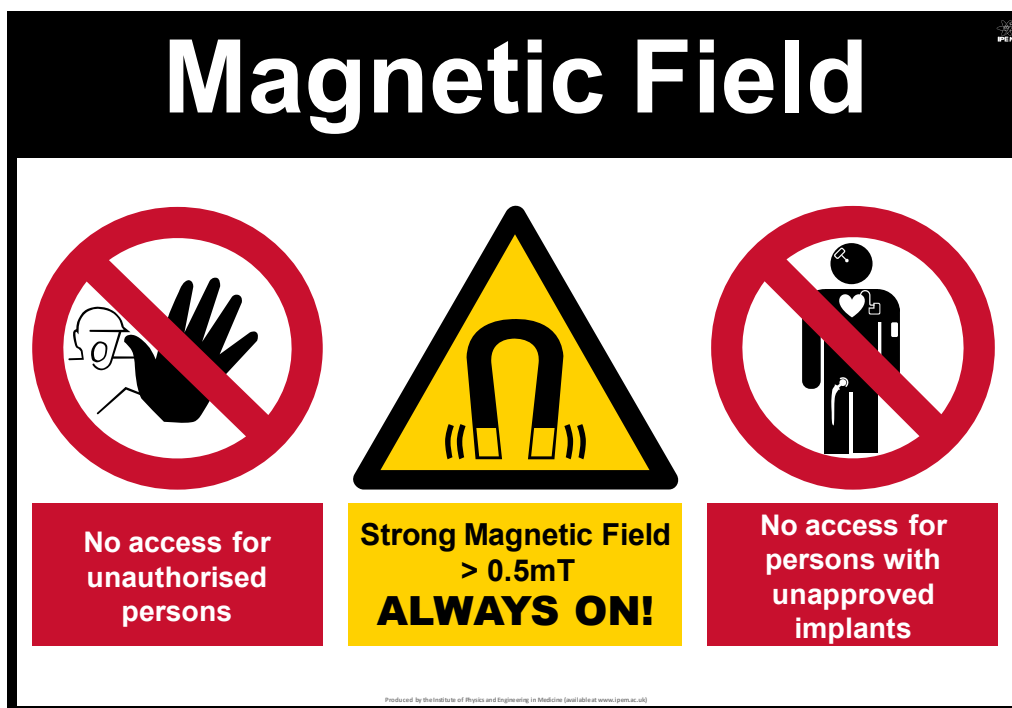
Figure 5: IPeM recommended MRI safety notice for entrances to regions with magnetic flux density >0.5mT, other than the MRI scanner room (e.g., an MRI equipment room).

- Figure 5 - IPEM recommended MRI safety notice for entrances to regions with magnetic flux density > 0.5mT, other than the MRI scanner room (e.g., an MRI equipment room).
(suggested size: A4 / 297mm × 210mm / 11.7in × 8.3in)

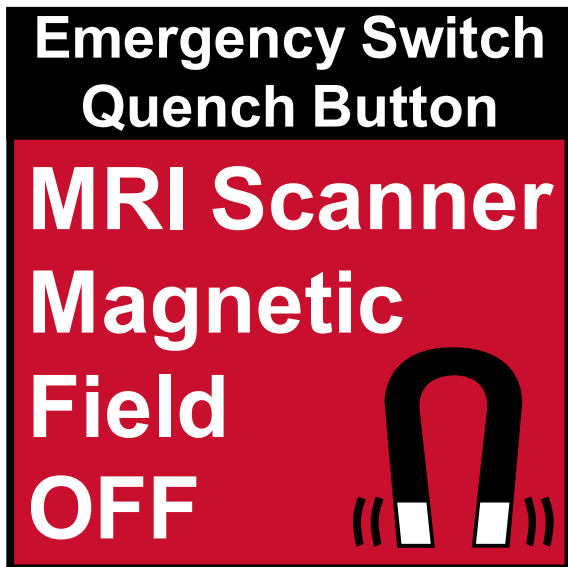
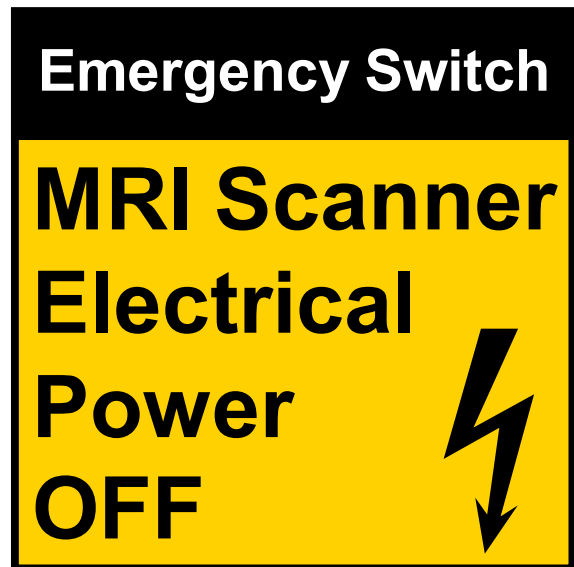
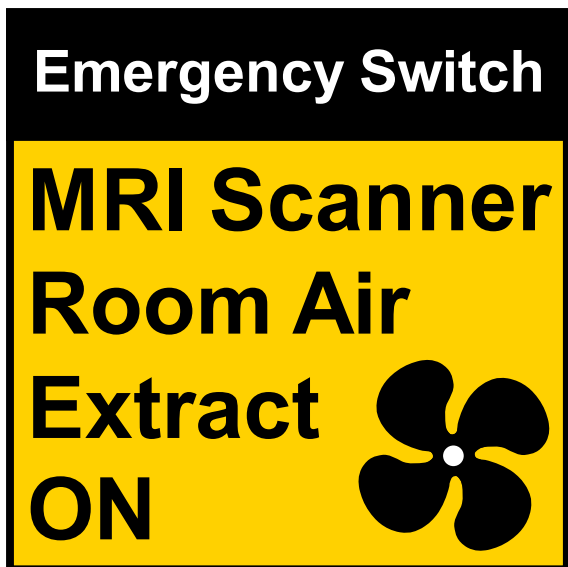
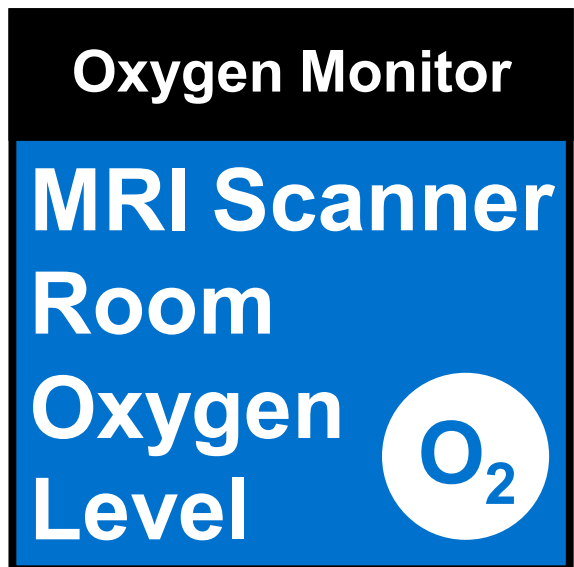
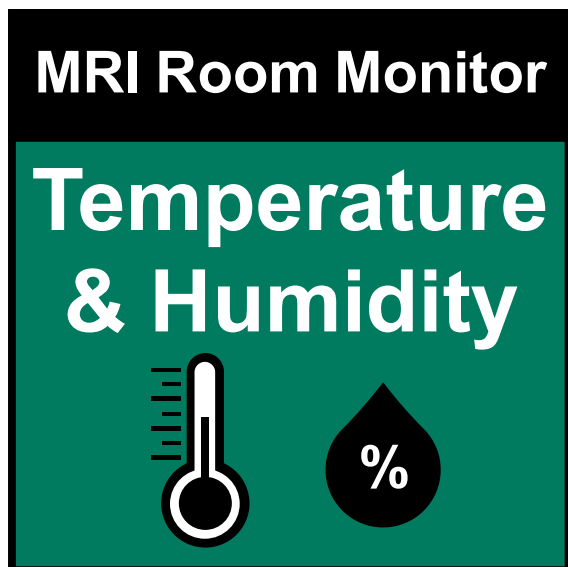
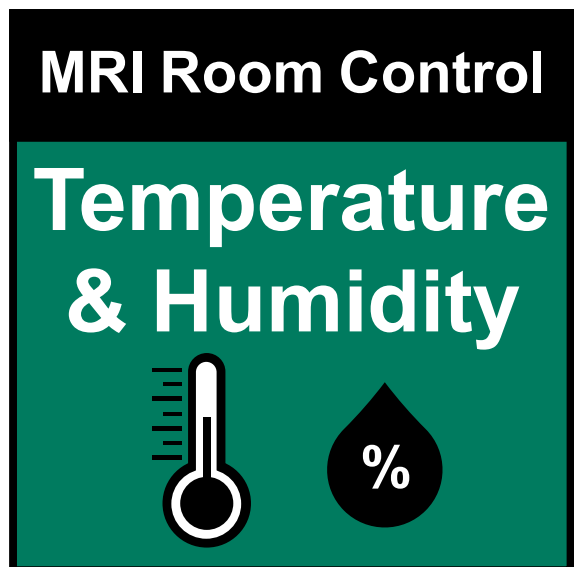
Figure 6: A sample set of labels for use in MRI departments to clearly and unambiguously label emergency buttons, the oxygen alarm/monitor and the environmental control/display.

The Working Party has created a sample set of labels (recommended minimum size: 90mm × 90mm / 3.5in × 3.5in) for use in MRI departments to clearly and unambiguously identify emergency buttons, the MRI scanner room oxygen alarm/monitor and the MRI scanner room environmental control/display. These are illustrated in figure 6.

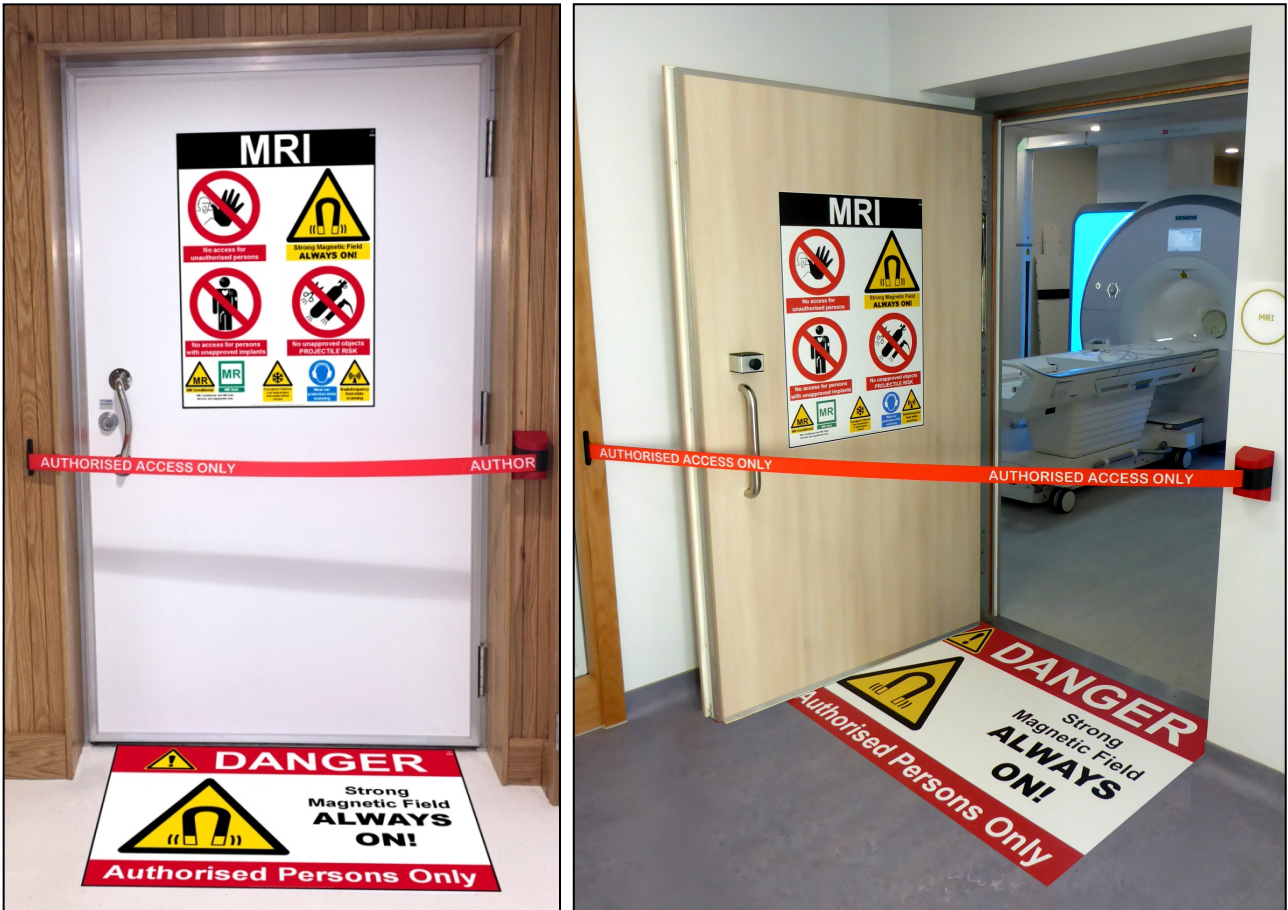
Figure 7: Examples of MRI safety notices in use and suitable physical barriers across the entrance to the MRI scanner room.

Examples of these MRI safety notices and emergency button, oxygen alarm/monitor and environmental control/display labels in use are given in figures 7 and 8.

Other safety measures similar to the above MRI safety notices that would enhance safety in MRI departments were also considered. The Working Party recommends an easily removable physical barrier across the MRI scanner room entrance, e.g. a retractable belt stating “AUTHORISED ACCESS ONLY”. Examples are shown in figure 7.

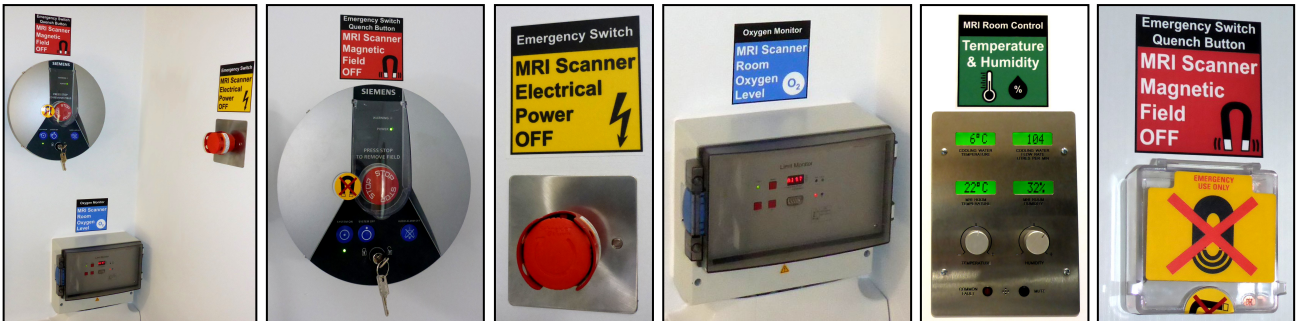
Figure 8: Examples of labels for emergency buttons, the oxygen monitor and the environmental control in use in both the MRI control room and the MRI scanner room.

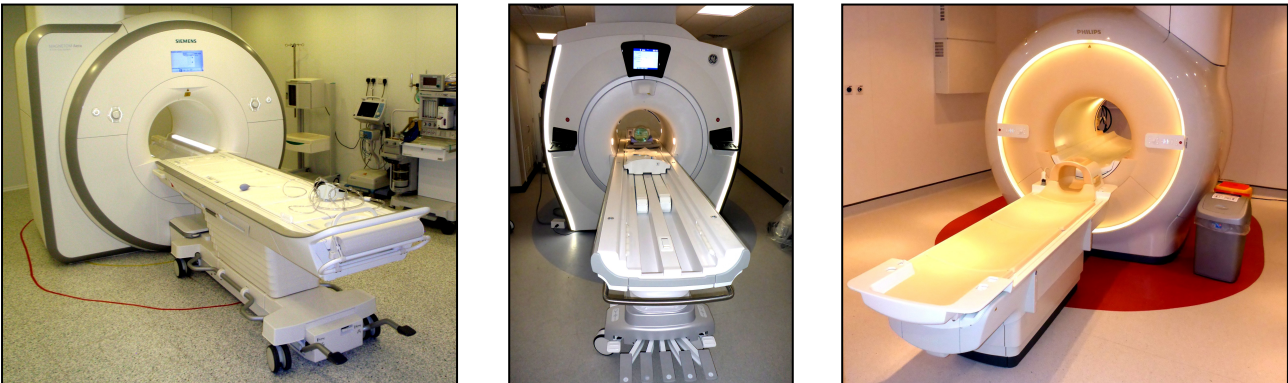
Figure 9: Examples of suitable floor marking within the MRI scanner room to aid safe working practices with regard to MR Conditional ancillary equipment.

MR Conditional ancillary equipment that is used in the MRI scanner room (e.g. an anaesthetics machine) usually has as one of its MR Conditions a magnetic flux density limit. The Working Party recommends floor marking or shading, following a suitable magnetic flux density isocontour at isocentre height, to clearly demarcate the region within the MRI scanner room into which the equipment should not be taken. Examples are provided in figure 9. A 10mT exclusion zone is appropriate for most MR Conditional ancillary equipment and should be considered at the design stage of an MRI scanner room. Sites may prefer to tailor the floor marking to meet specific MR Conditions for their equipment.
